Submission to the Environment and Communications Legislation Committee

The impact of feral deer on the natural environment at the Banksia Bush Care Site, Stanwell Park, N.S.W.

ABSTRACT

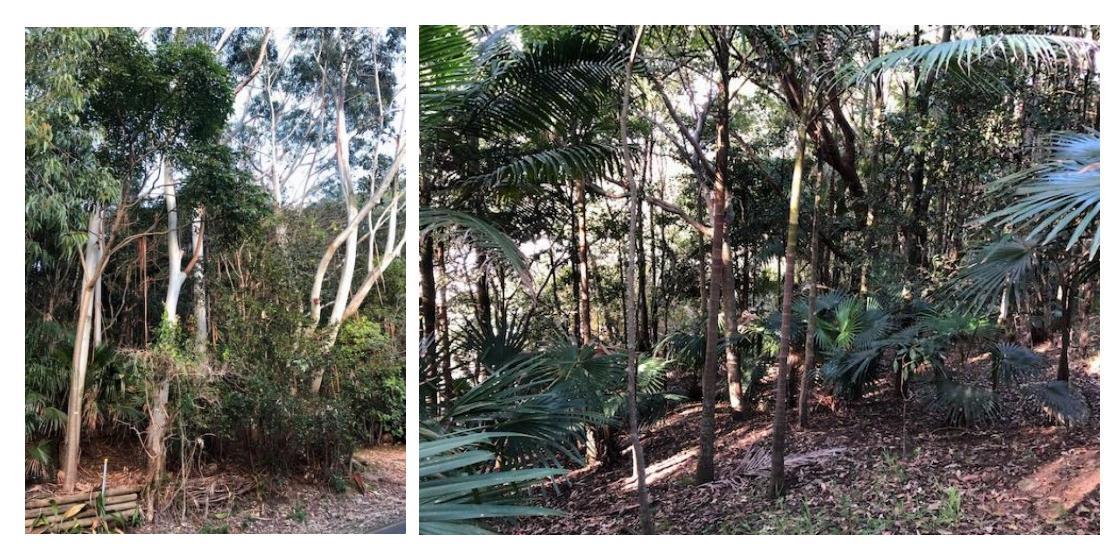
The Blue gum forest behind the Kiosk, and the rainforest further uphill. These trees were planted 30 years ago, and none of them needed any protection because deer had not then started to come into Stanwell Park.

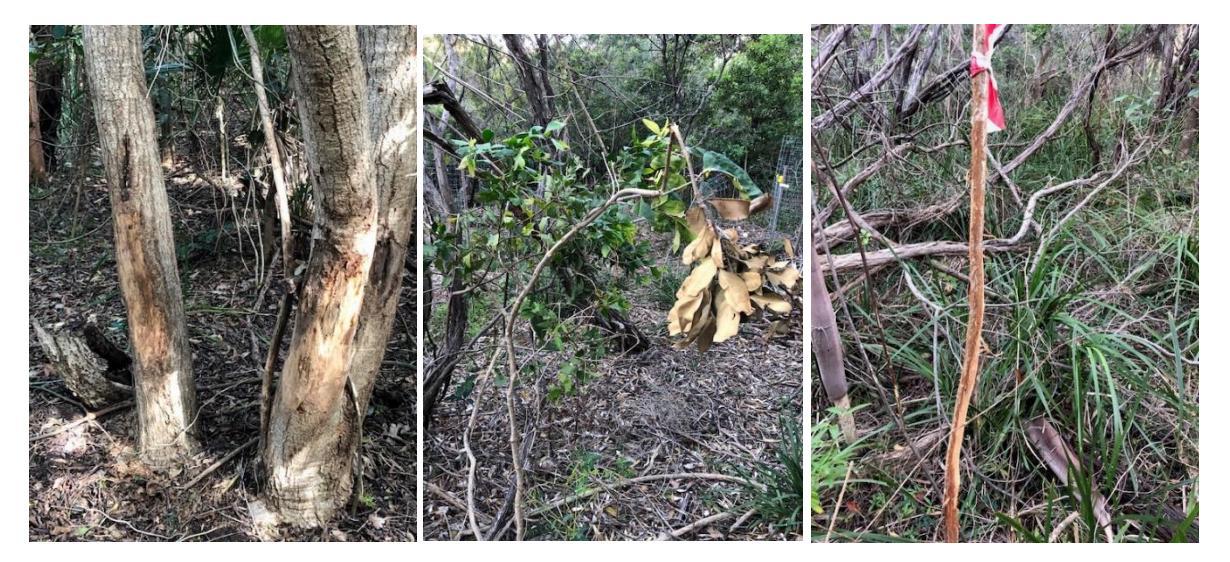
Three examples of deer damage: in the first example, severe partial ringbarking to very old Polyscias elegans (Celery wood). The tree will probably survive because the ringbarking has not been complete, but around the other side of the tree is a very old scar of a similar attack in the past. In the second, the deer has partially ringbarked the trunk, but then broken the tree in half. In the third, I had marked this tree with safety tape with the intention of protecting it with wire or ochna trunks, but when I got around to doing it, it was too late. It had been totally ringbarked and killed.

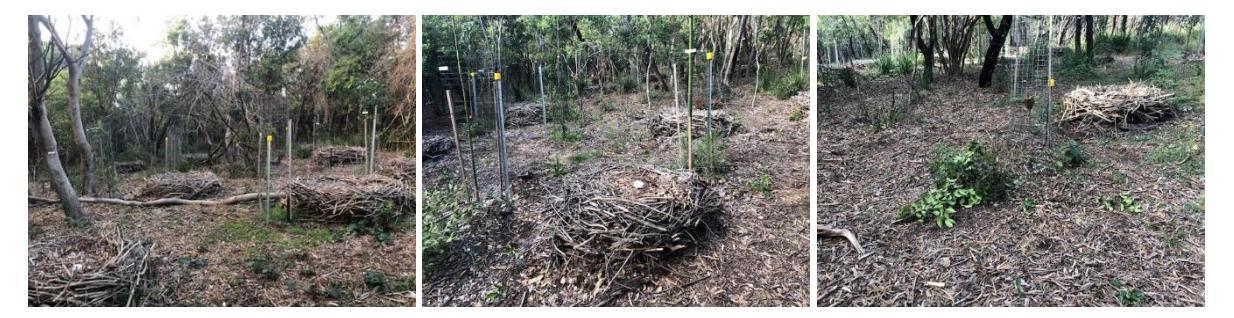
The circle part of Banksia Bushcare site two years after removal of lantana, ochna and cassia. Deer have destroyed most of the native regrowth

The circle part of the Banksia Bush Care area shown above was heavily infested with lantana and ochna. The height of the lantana can be seen in the background of the first photo. The banksias were getting old and one in the first photo had blown over onto the ground. The clearing of the lantana and ochna was completed some two years ago. There were very few young trees that survived the weed infestation, and those that did survive were destroyed by the deer once they could get at them. Most of the native trees that sprouted since the clearing, such as cheese trees, were

immediately eaten by the deer. Some trees, such as Lilly Pilly, whose leaves are not normally eaten by deer, were broken off close to the ground. The third photo shows one of them.

We built cages out of wooden stakes, star pickets and flower wire that I mostly bought with my own money and which Wollongong Council occasionally purchased for us. These cages are shown in the above photos and are largely effective. Occasionally the deer have destroyed one where only wooden stakes were used, and we are now reinforcing all of them with star pickets.

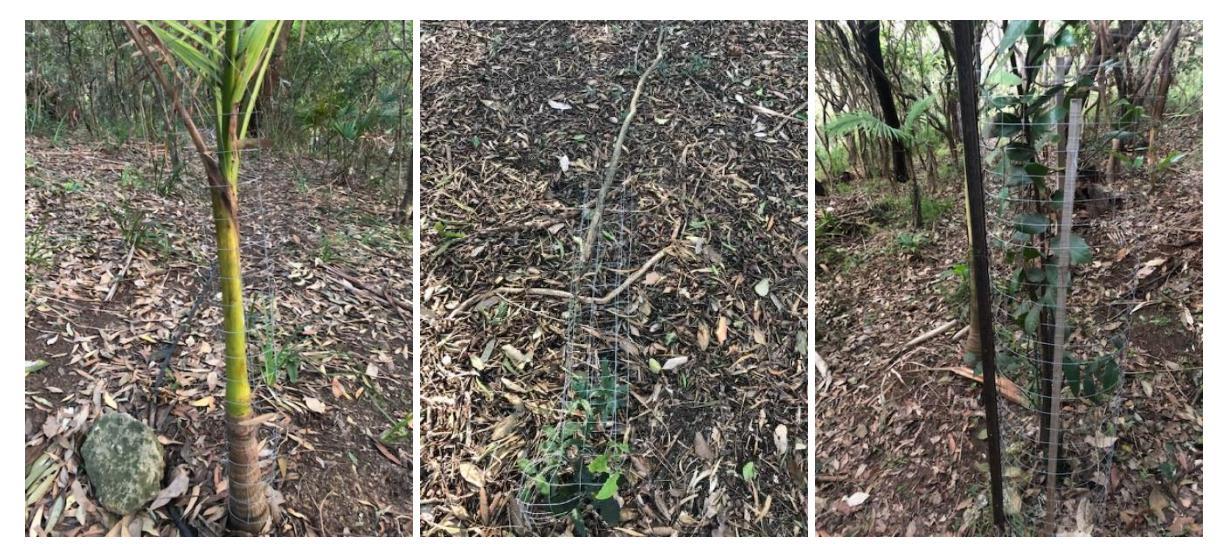
The Bangalow palm in the first photo was attacked by deer through rubbing. Its roots were affected as it can be easily shaken. Flower wire was put around for protection, but its new shoots are significantly smaller than before, despite the assistance of a dripper. In the second photo a Guioa which had been protected by flower wire was still destroyed by a deer snapping it off. Flower wire around small trees is not always foolproof. The third photo is one of the 40 sandpaper figs eaten to the ground by the deer over two nights. A couple of the destroyed figs started to regrow from the roots, and I was able to protect them by a cage.

We protected the existing trees from ringbarking, and did this by wrapping flower wire around their trunks. This seems to discourage the deer from sharpening their antlers on them.

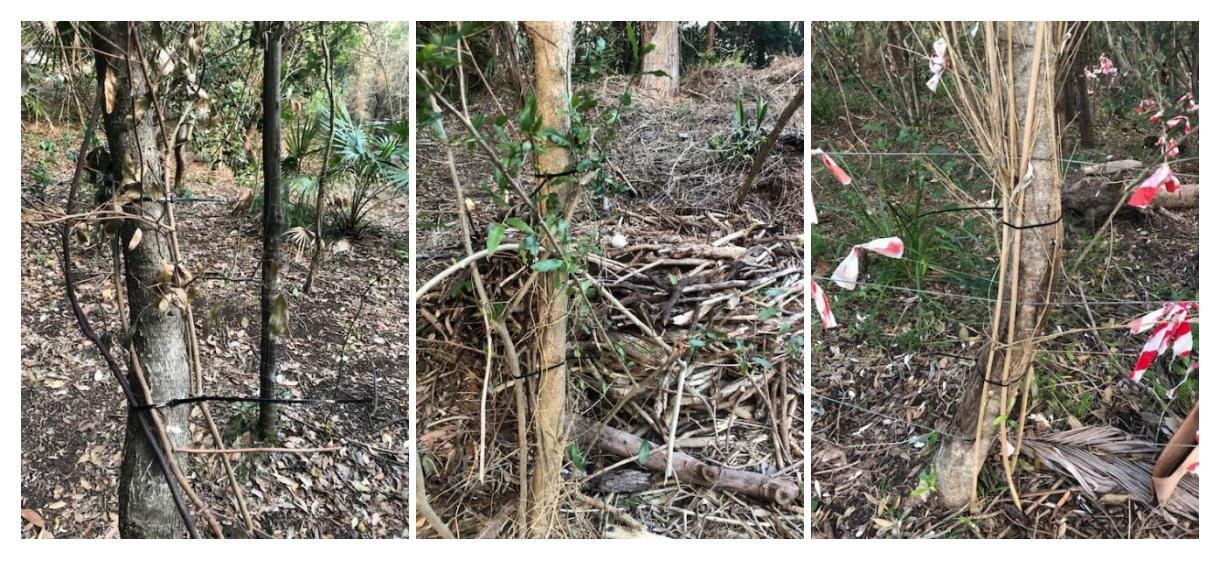
Ochna, lantana and bamboo tied on with cable ties to mimic low lateral branches.

I had noticed that the deer rarely damaged a tree with low lateral branches, presumably because they would get in their eyes while doing a rub. There was a new use for the tonnes of ochna plant that we removed. We could wrap them around the trunks to imitate the function of low lateral branches. They are held on with cable ties. Anything that resembles low lateral branches is suitable. In the last photo below, we have used bamboo cuttings. This method seems to work.

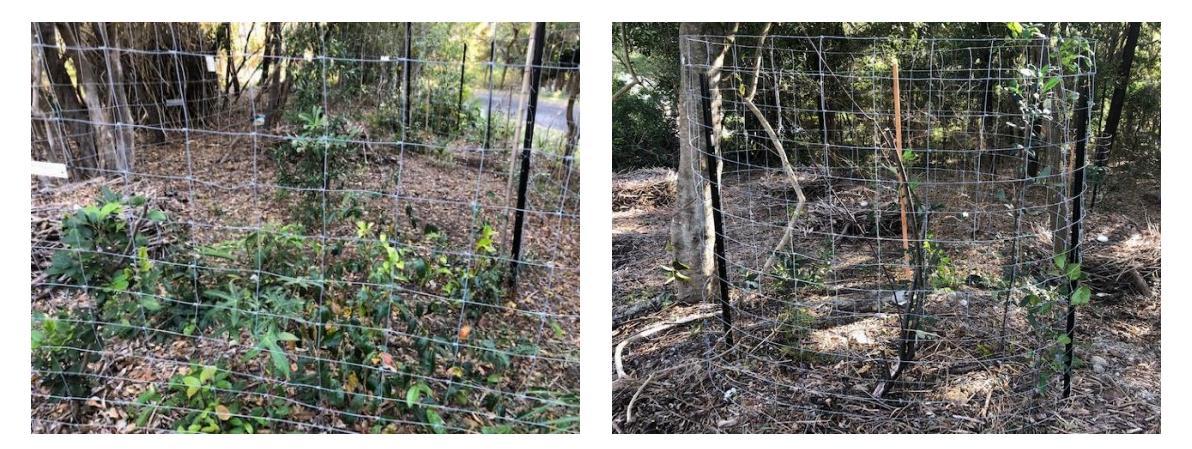
First photo: The difference between the area protected by hinge wire around a regenerating copse and the bare ground beyond it, eaten out by deer is significant. In the second photo we found three young Guioas and a Tuckeroo struggling for some light amidst a stand of cassia and ochna, and then used the hinged wire to create a copse.

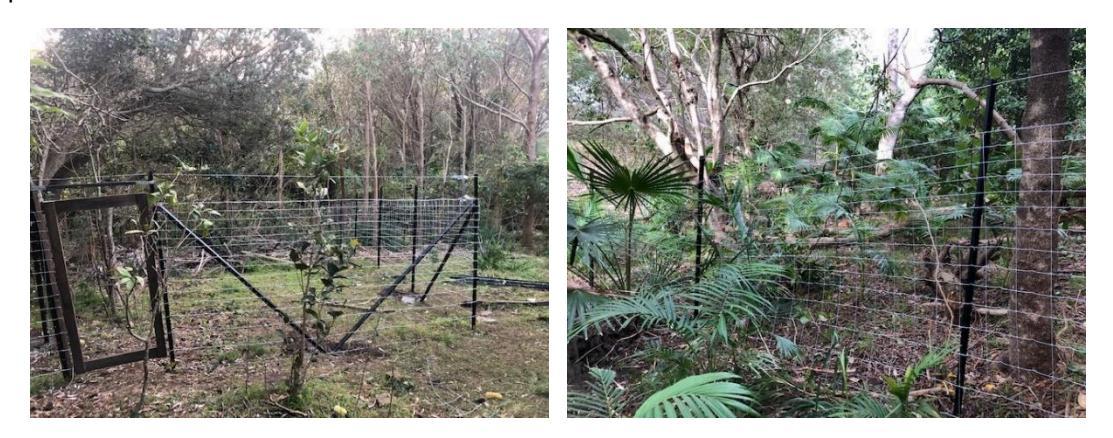
Deer fence around a sensitive are behind the sand dune at Stanwell Park Beach where the deer had been attacking over 100 Bangalow palms.

Some parts of the Banksia Bush care site have been so denuded of grasses and undergrowth that they now look like a cattle yard. I approached the Council late last year about purchasing the materials for a 150 metres of deer fence around a particularly sensitive area where deer had been attacking mature Bangalow palms, germinated and planted by another Stanwell Park bush care volunteer. They had also partially or completely ringbarked nearly all the rainforest trees in the area. The fencing wire and star posts were duly supplied, and the Banksia Bushcare volunteers have now completed it.

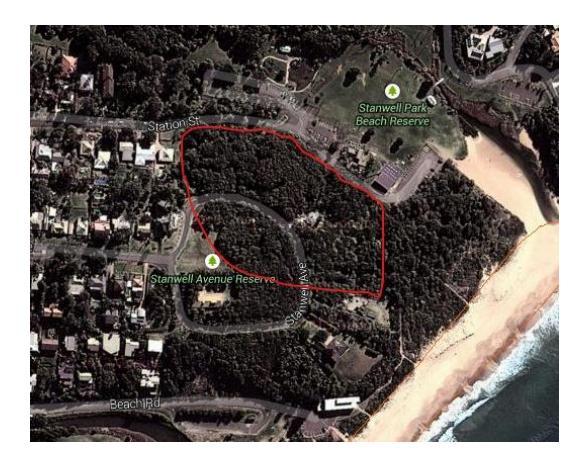
Area of the survey in red

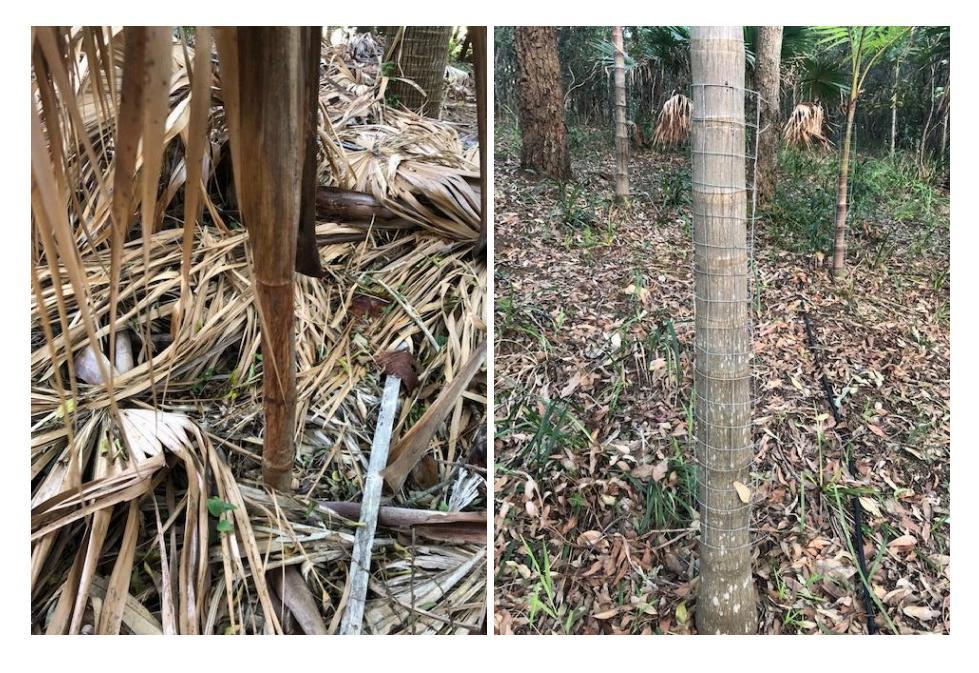
First photo: A Bangalow palm rubbed by deer. Death seems to result from snapping the roots. Second photo: All Bangalow palms, this size or under now have to be protected by flower wire or being tied with sticks.

Archontophoenix cunninghamiana (Bangalow palm) cannot be ringbarked, as it is a palm. However, 18 of them have been killed by the deer by rubbing against them, and it seems that they have snapped the palm's roots. Some of the ones that died have been 3 metres tall. As a result, apart from very large Bangalows, I have had to discourage the deer by flower wire around the trunk or binding dead ochna to them. Bangalow palms have also been attacked by branches being broken and eaten. The deer fence erected near the main walkway to the beach was to protect the flourishing forest of Bangalows.
